# **ALAMO PLAZA EXISTING BUILDINGS**

## **HISTORICAL ASSESSMENT**

**JOHN G. WAITE ASSOCIATES, ARCHITECTS PLLC • SEPTEMBER 2020**

*prepared for the*  
**ALAMO TRUST, INC**

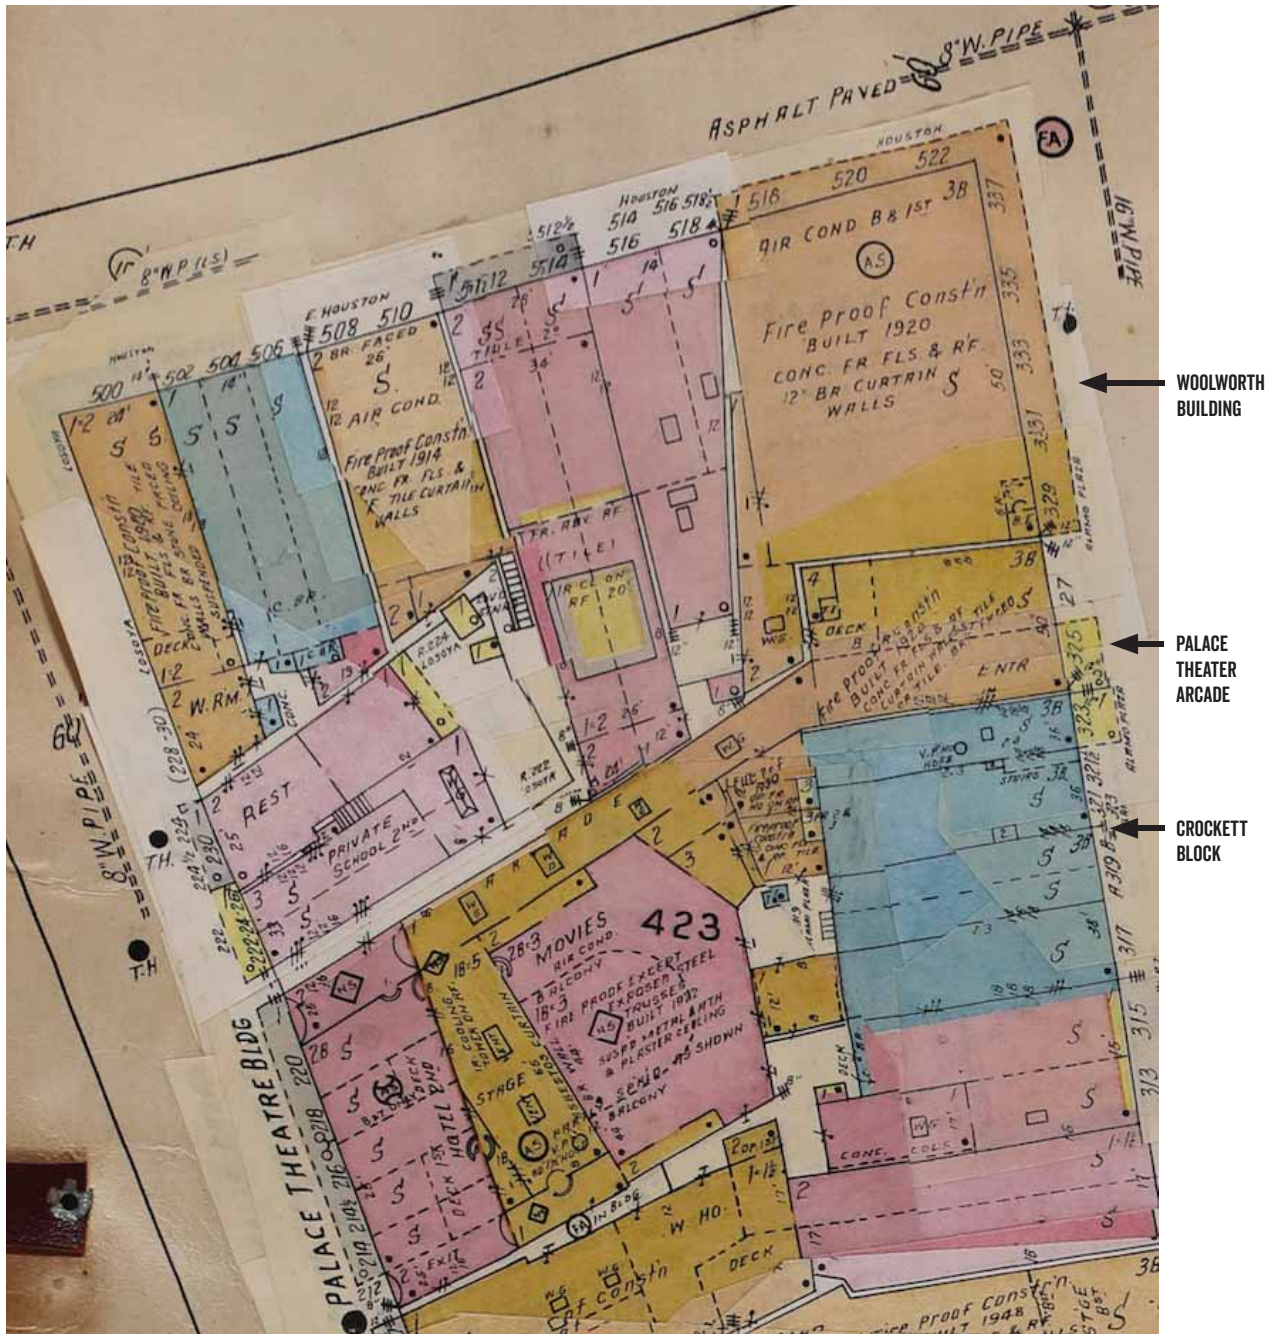
1951 Sanborn map. The Palace Theater is still shown. The auditorium and part of the Arcade would be demolished in 1954. Library of Congress.

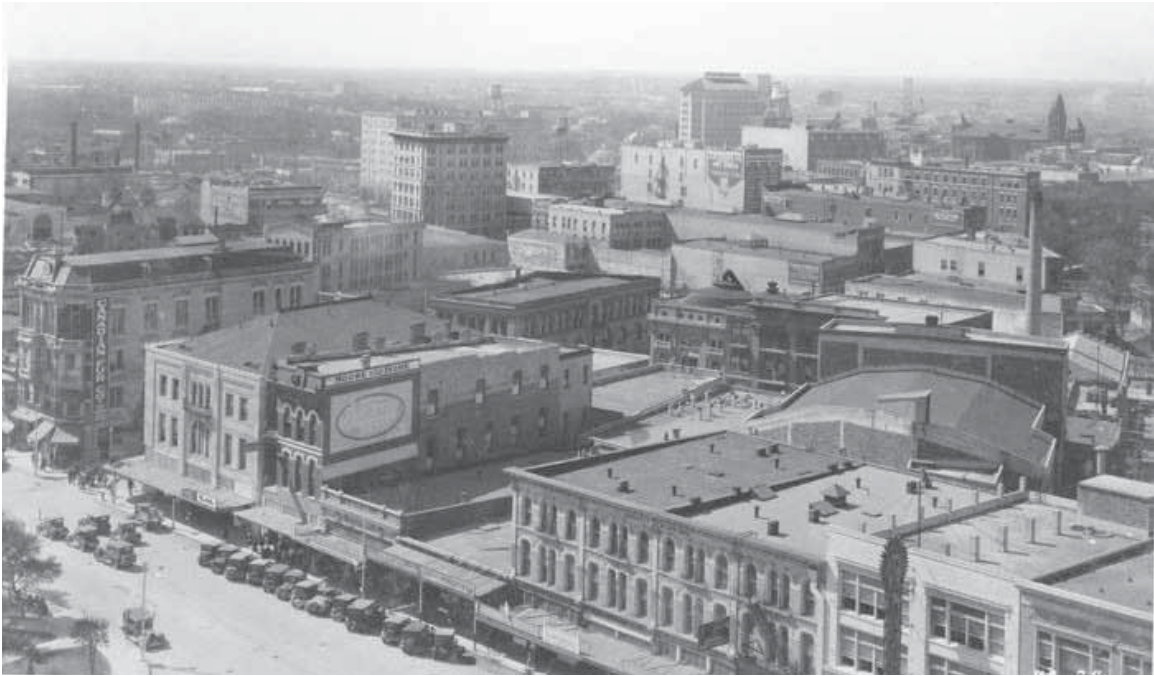
This 1927 photograph, taken from the roof of the Medical Arts Building, shows the roof surfaces of the Palace Theater and the Crockett Block. Note the concrete piers on the roof of the theater building and the curved roof of the theater auditorium behind the Crockett Block. UTSA Institute of Texas Cultures.

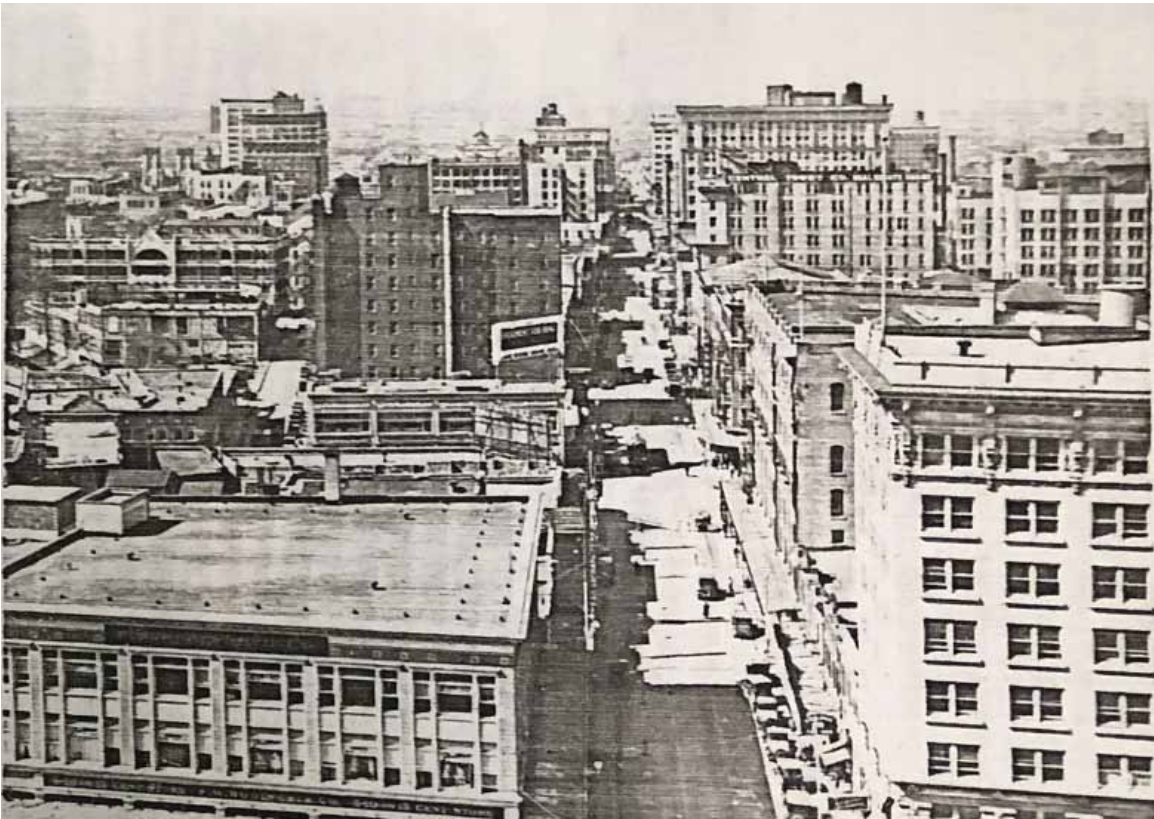
This 1927 photograph shows the roof surface of the Woolworth Building. The small structure at the southwest corner of the roof is still in place today. UTSA Institute of Texas Cultures.

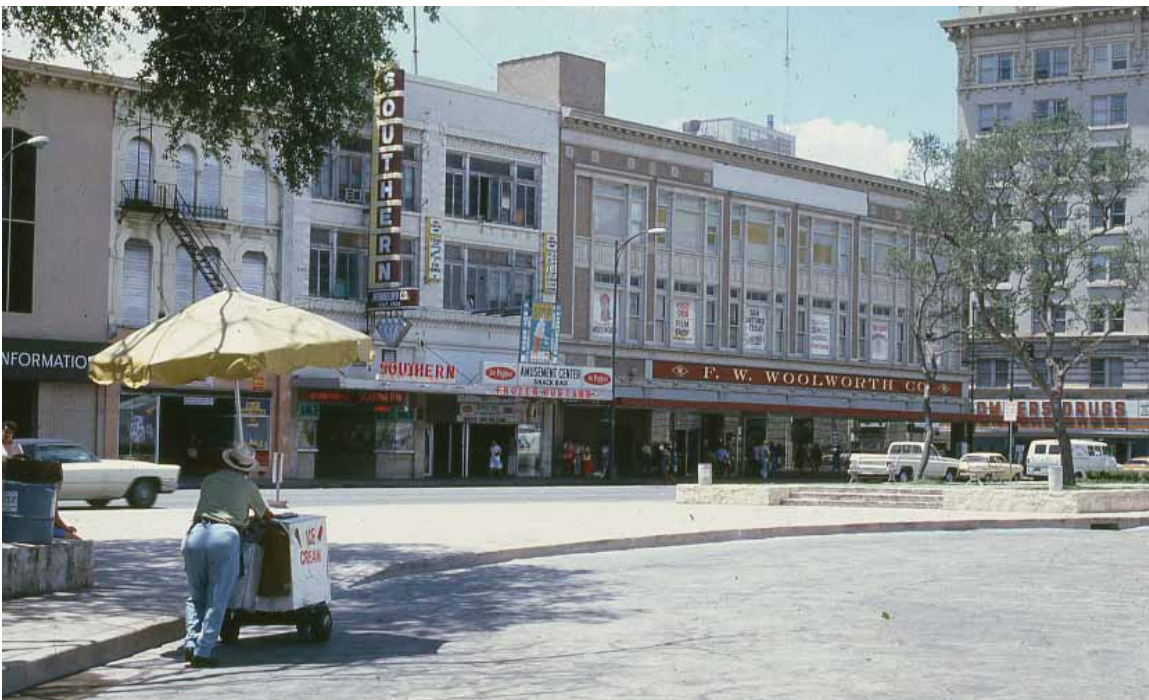
This circa 1976 photograph records the various modifications made to the three buildings on the west side of the plaza. Note the simplified red painted edge of the Woolworth canopy. UTSA Institute of Texas Cultures.

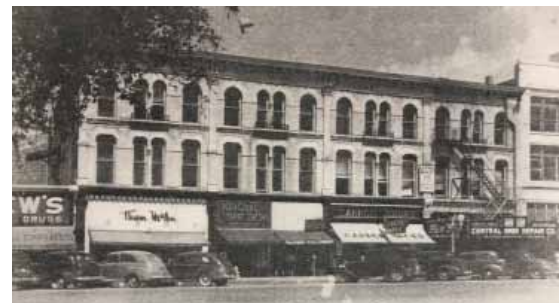
This early 1940s photograph of the Crockett Block records the extensive modifications made to the storefronts. Note the fire escape at the north end of the block. UTSA Institute of Texas Cultures.

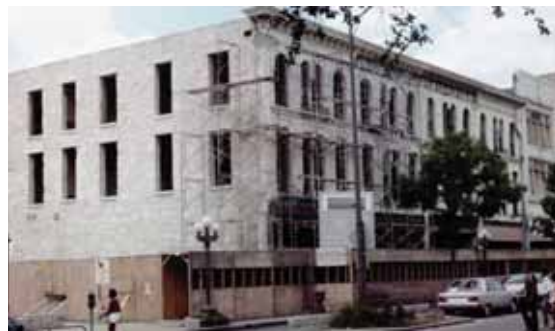
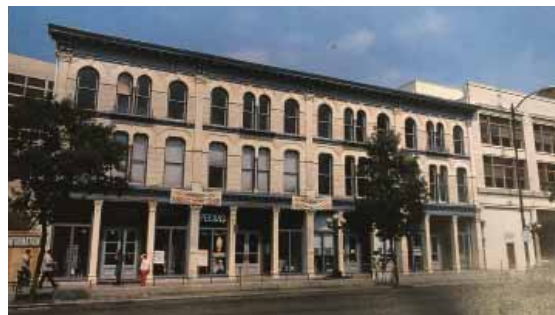
The east facade of the Crockett Block, during and after the extensive restoration of that building. The Palace building is unoccupied, and the Southern Jewelry Company sign has been removed. UTSA Institute of Texas Cultures.

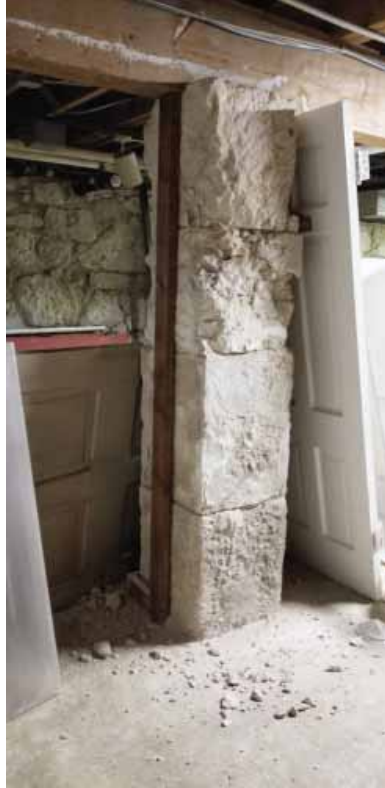
Crockett Block. Basement hallway, looking south (above); and deteriorated stone pier supporting first-floor framing (left). JGWA, 2019.

**BASEMENT:** during the 1983 work, the basement floor was lowered approximately 18", and stone piers were removed and replaced or augmented with steel bearing plates. Mortar loss at the base of the stone masonry walls suggests rising damp may be a concern.

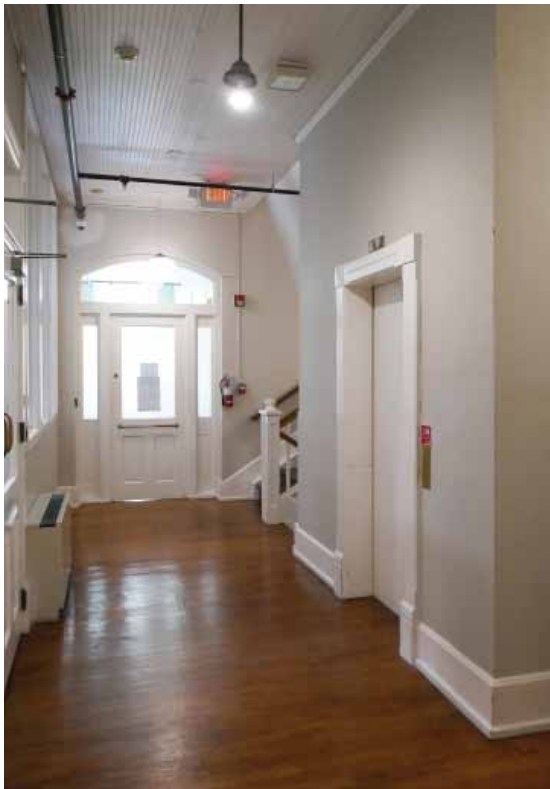
Crockett Block. Second-floor hallway, looking south. Note the elevator shaft and stairway constructed during the 1983 renovations. JGWA, 2019.

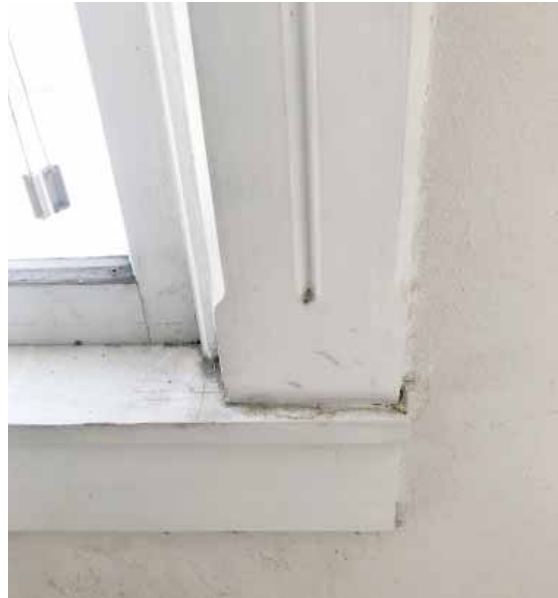
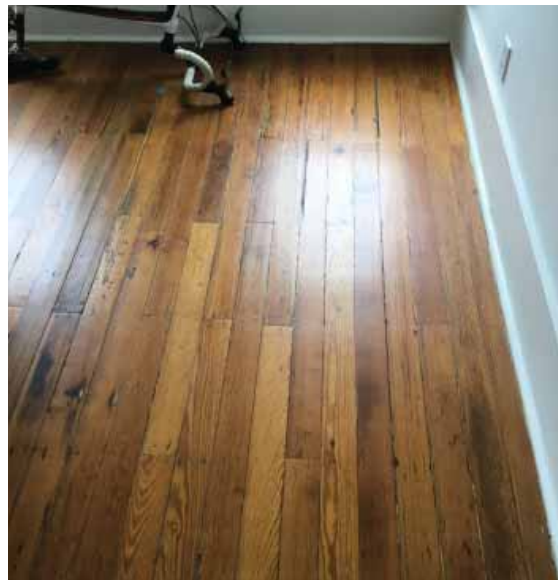
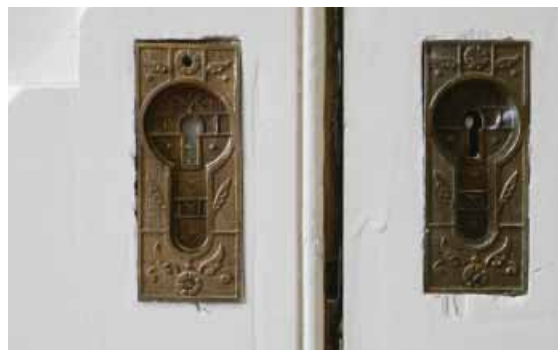
Crockett Block character-defining features: typical window trim (upper image); wood flooring (center); hotel-era hardware on a pair of sliding doors (lower image). JGWA, 2019.

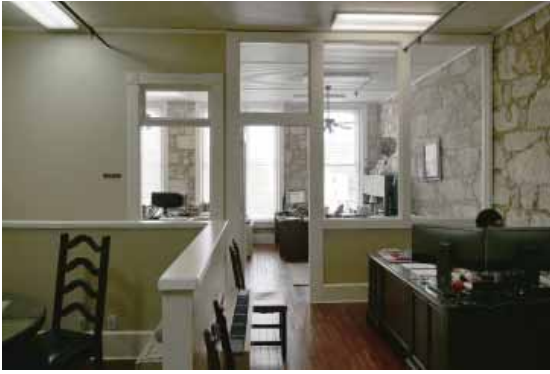
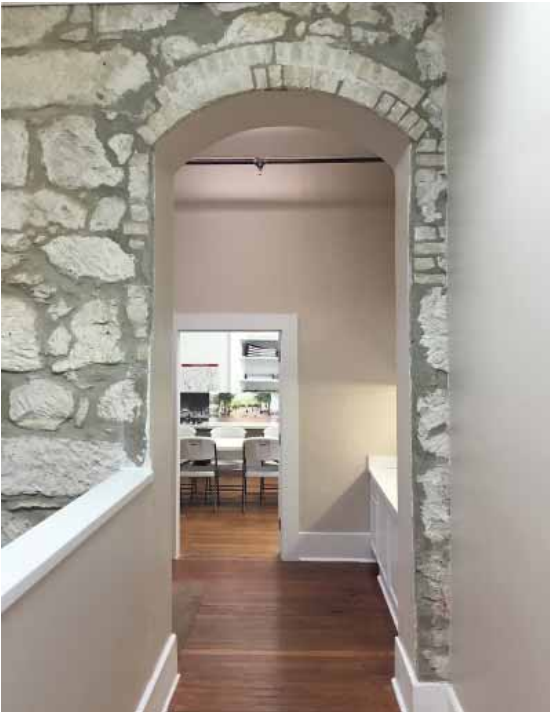
Crockett Block. Second-floor office in no. 319, looking east (upper image) and north (above). Note the historic stone wall of the front façade and the historic stone wall that divides no. 319 from no. 321. JGWA, 2019.

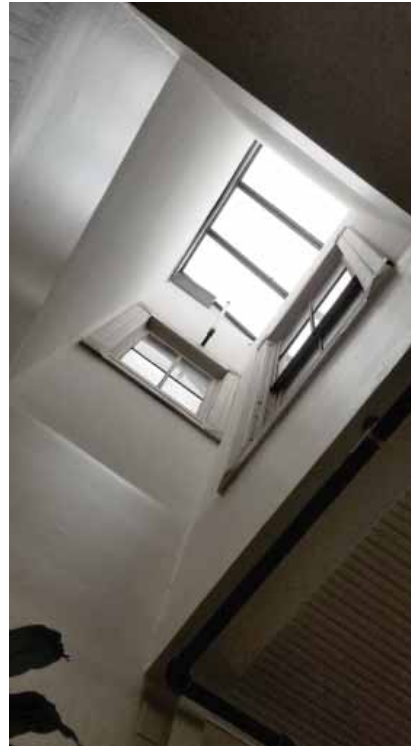
Crockett Block. Existing lightwell, looking up from a second-floor office. Interior windows at the third floor are character-defining features that provided daylight into the central spaces of the buildings. JGWA, 2019.

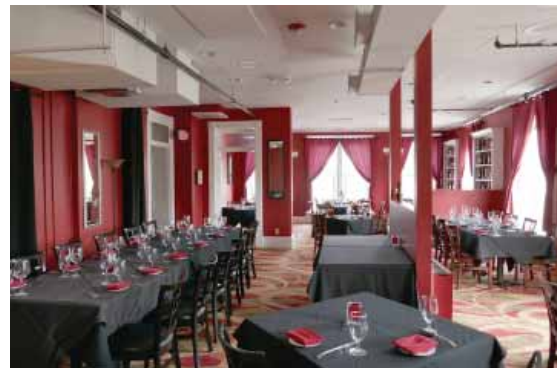
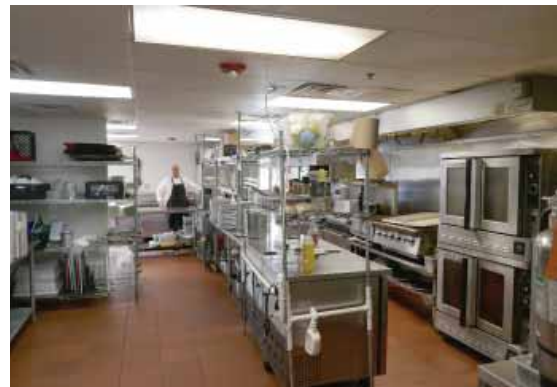
Crockett Block. (Upper image) Third-floor restaurant (1718 Steakhouse) dining room, looking east within no. 317. The hotel-era doorways with their transoms are character-defining features throughout the third floor. The lower image shows the third-floor restaurant kitchen in the northwest corner of no. 323, looking west. JGWA, 2019.

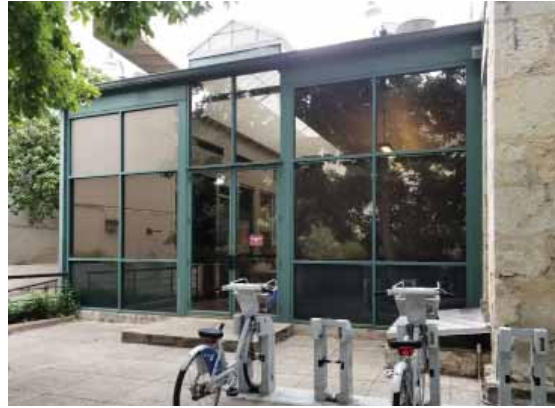
**Crockett Block.** South entrance to the rear (west) addition, constructed during the 1983 renovations. This one-story metal and glass addition is a non-contributing feature of the building's exterior. JGWA, 2019.

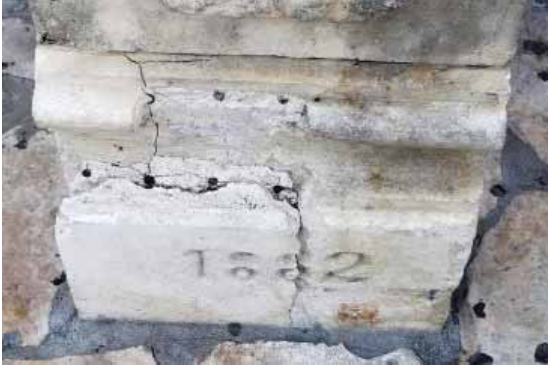
Crockett Block. Deteriorated base of stone pier on east elevation. JGWA, 2019.

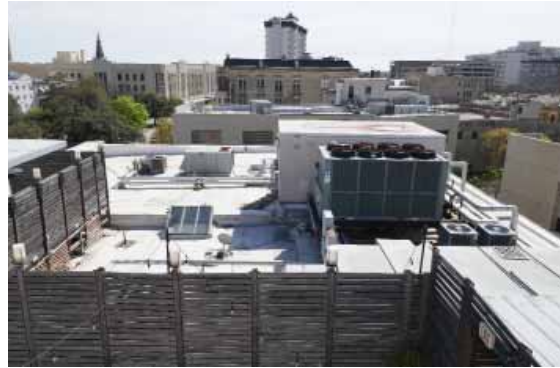
Crockett Block. Roof, looking south. An original skylight location is visible in the center of the photograph. JGWA, 2019.

The roof is reported to have been recently replaced; however, there are a few areas where the insulation beneath may be deteriorated, and further investigation at these locations and other areas where past fire damage to roof framing has been noted should be performed. The historic skylight locations remain; there are no reported leaks at these locations, despite the age of the replacement skylights.

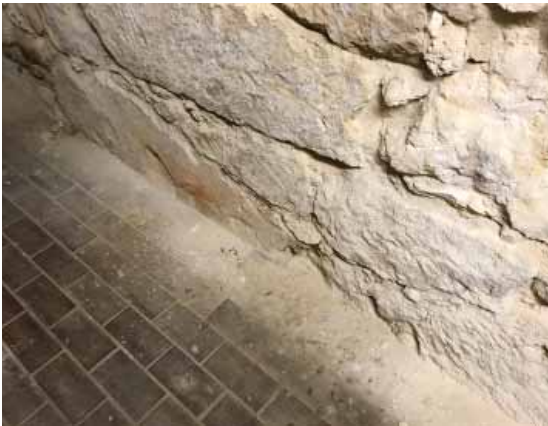
Crockett Block. Deteriorated stone wall in basement, indicating a problem with rising damp. JGWA, 2019.

The mortar loss is actually most pronounced at the interior basement level, where capillary action and water vapor migration associated with the presence of a high water table are likely the cause of the loss of binder in the mortar. This problem has probably been exacerbated by the 1983 renovations, when archival documents indicate the basement floor level was lowered approximately 18" below the historic basement floor construction. Atmospheric soiling can be found primarily on the upper portions of the south and west walls, where parapet cap flashing details are not providing a sufficient drip edge and mortar joints between coping stones are deteriorated or missing.

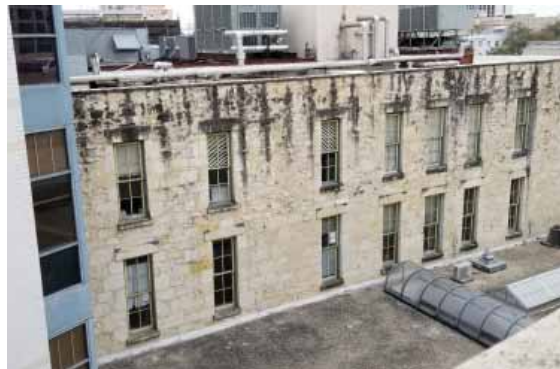
Crockett Block. West elevation. Note the staining at the top of the stone wall. JGWA, 2019.

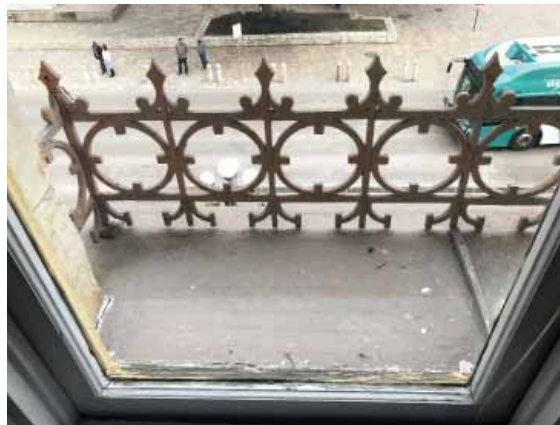
Crockett Block. Third-floor east window balcony, with iron rail. The reproduction belt course installed during the 1983 renovations appears to be fiberglass. JGWA, 2019.

Decorative trim at the building exterior is both historic (cast iron columns and wrought iron balconettes) and replacement material (fiberglass cornice and trim elements). The fiberglass material is beginning to show evidence of deterioration, and the iron elements exhibit minor corrosion due to lack of maintenance repainting.

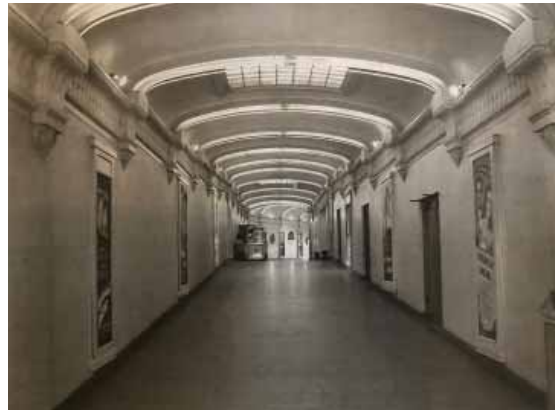
The Palace Theater Arcade in 1945, looking east from the Losoya Street entrance. Note the floor that ramps upward to the concession stand, and the entrance to the auditorium to the right. This reflects the slope of the floor within the auditorium. UTSA Institute of Texas Cultures.

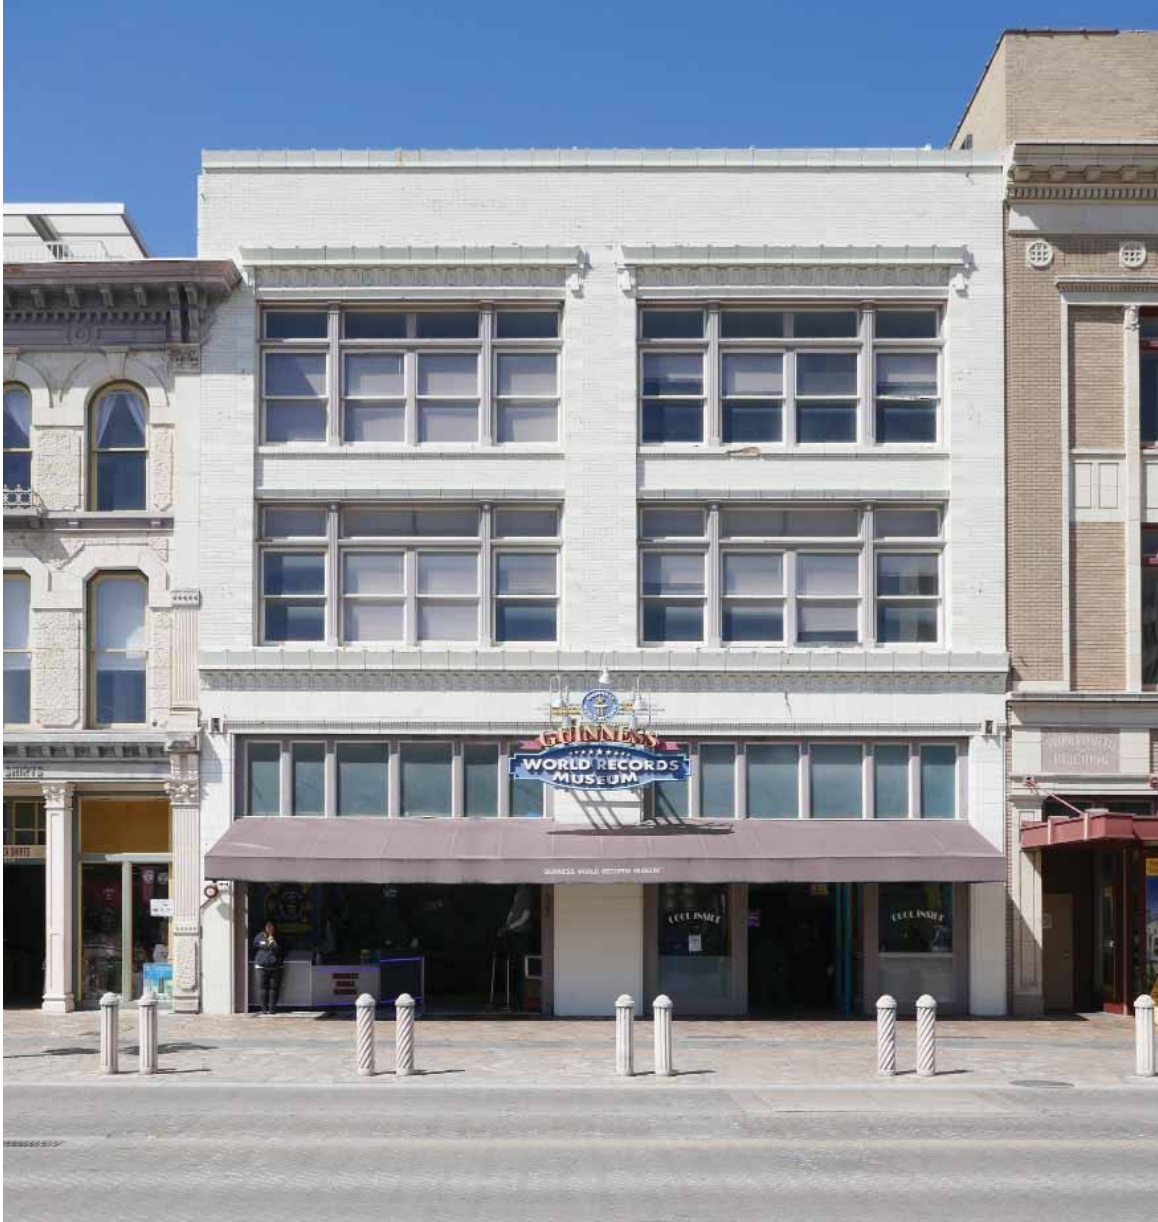
Palace Theater Arcade. East elevation. JGWA, 2019.

The exterior east façade of the Palace Theater Arcade was restored during the 1983 renovations and is in very good condition overall. Minor cracks and spalls were observed at terra cotta trim elements at the belt course below the second-floor windows and at the parapet; the glazed brick masonry is in very good condition. The second and third floor windows are in good condition, but require repainting, reglazing, and adjustments to hardware to be

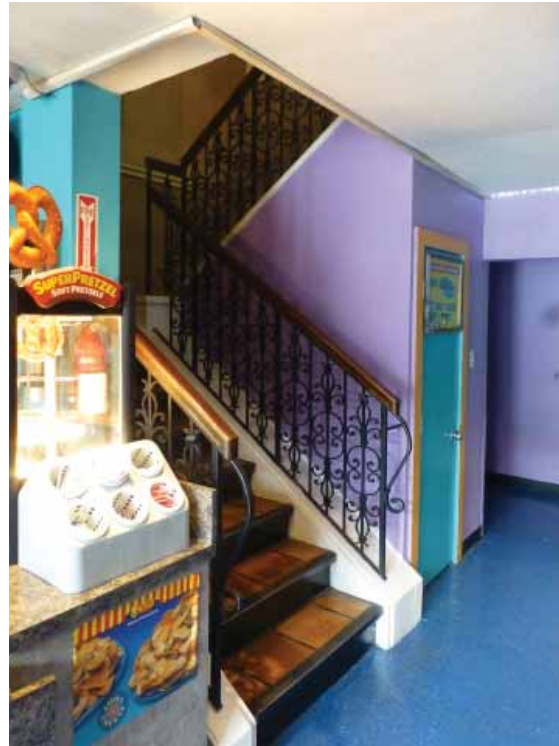
Palace Theater Arcade. Historic stair to mezzanine level. JGWA, 2019.

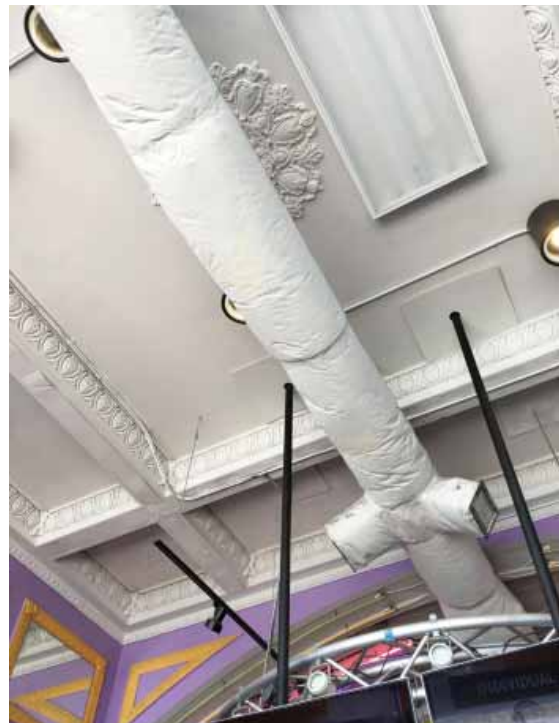
Palace Theater Arcade. Arcade entrance, with historic ornamental plaster ceiling. JGWA, 2019.

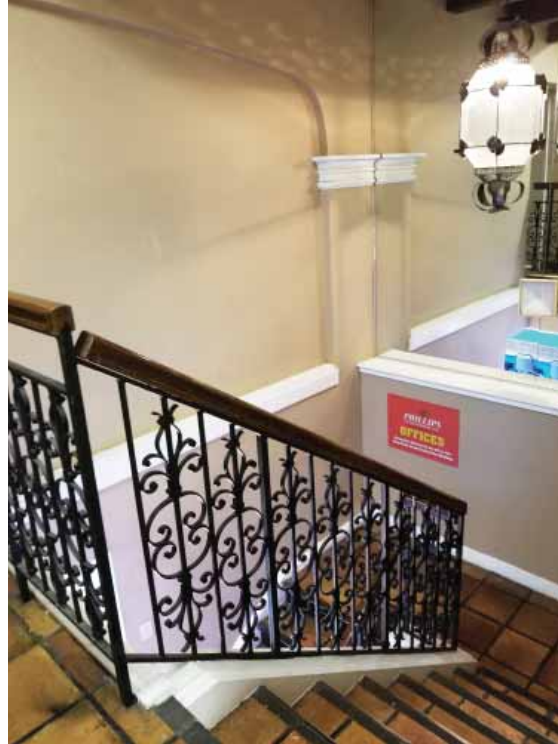
Palace Theater Arcade. Historic mezzanine stair with tile floors and ornamental railings, looking southeast. JGWA, 2019.

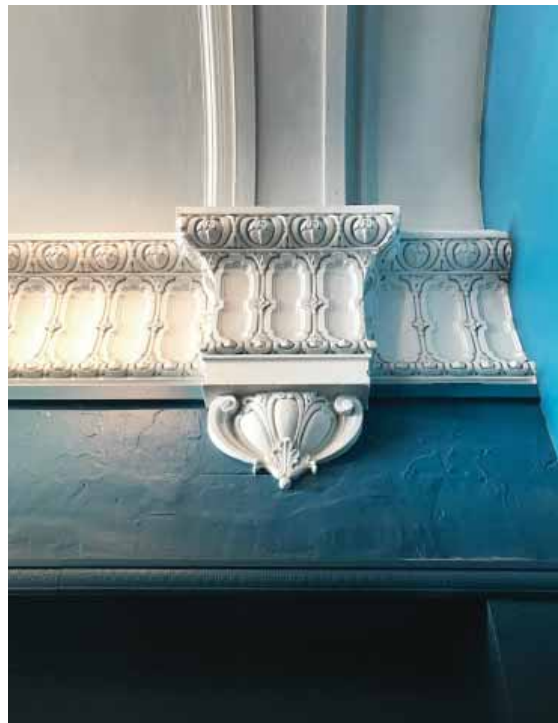
Palace Theater Arcade. Plaster detailing of historic vaulted Arcade ceiling. JGWA, 2019.

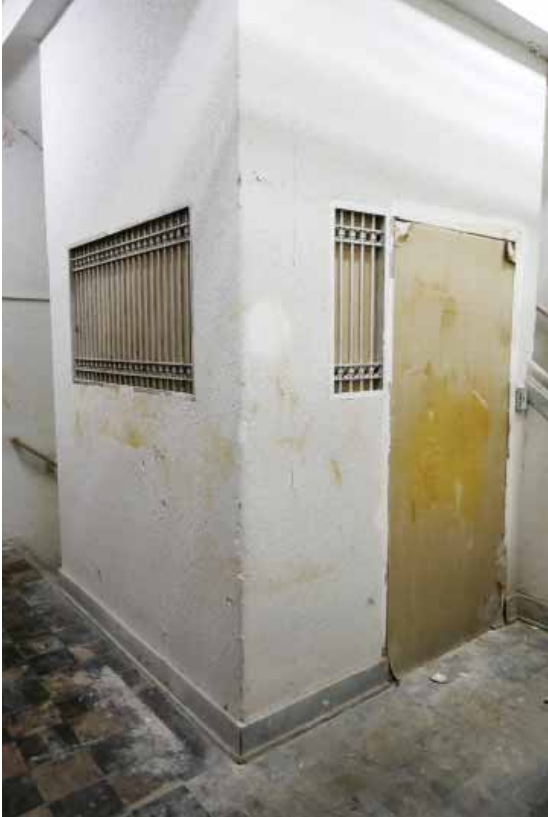
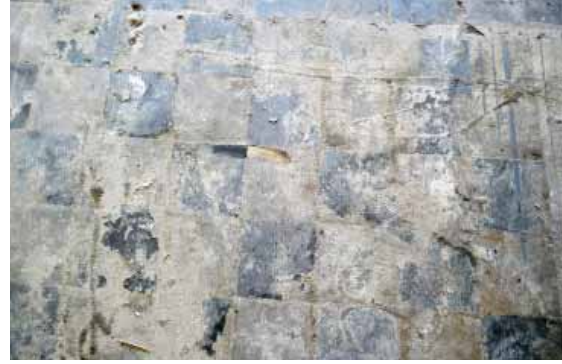
Palace Theater Arcade. (Upper left) Historic second-floor elevator shaft in the northwest corner of the building.

(Lower left) Historic concrete stair that wraps around the elevator shaft. JGWA, 2019.

(Above) Evidence of historic floor tile finishes near the historic elevator.

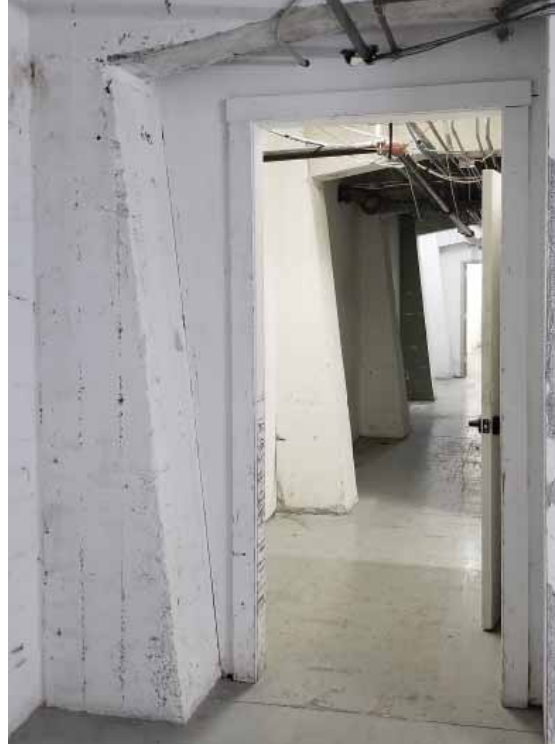
Palace Theater Arcade. Basement hallway with concrete foundation piers. JGWA, 2019.

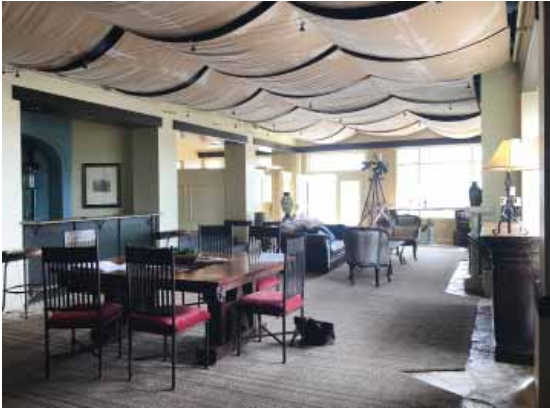
The penthouse construction on top of the historic roof of the Palace Theater Arcade is not historic, and appears to represent two construction campaigns, one unfinished in the 1960s and another completed in the early 1990s. The brick veneer of the exterior wall construction is beginning to separate at the northeast corner from the concrete masonry unit back-up wall construction; this should be investigated further to determine if the problem is a localized or pervasive failure condition. The ballasted roof system of the penthouse construction is in fair condition, with a very small gravel stop and drip edge at the roof perimeter. The associated wood deck assembly is in fair condition, and the metal railing is beginning to corrode and is not sufficiently anchored.

Palace Theater Arcade. Penthouse, looking east. The interior of this space was renovated in 1993 in the “Texas chic” style. JGWA, 2019.

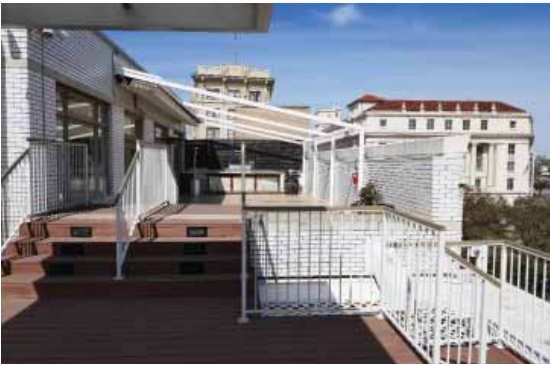
Palace Theater Arcade. Penthouse terrace, looking north towards the roof of the Woolworth Building. JGWA, 2019.

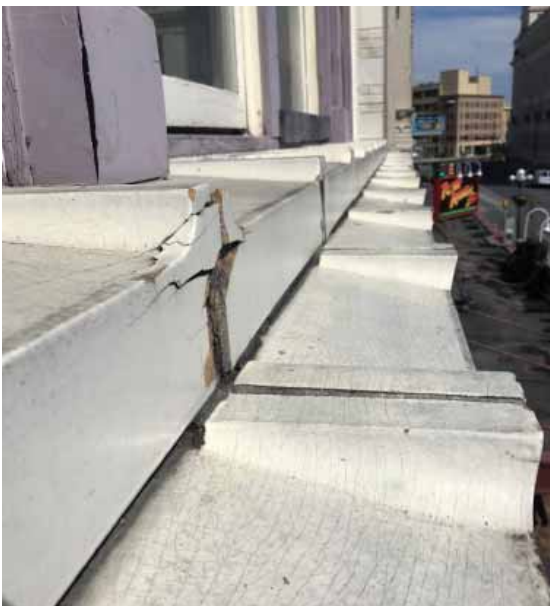
Palace Theater Arcade. Band of terra cotta, forming a cornice between the first and second stories of the east facade of the building. JGWA, 2019.

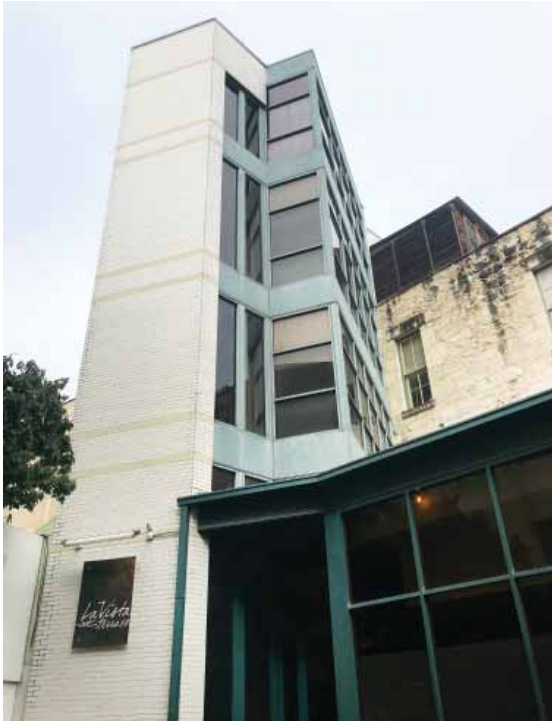
Palace Theater Arcade. Stair and elevator tower addition constructed during the 1983 renovations, with Crockett Block to the right. JGWA, 2019.

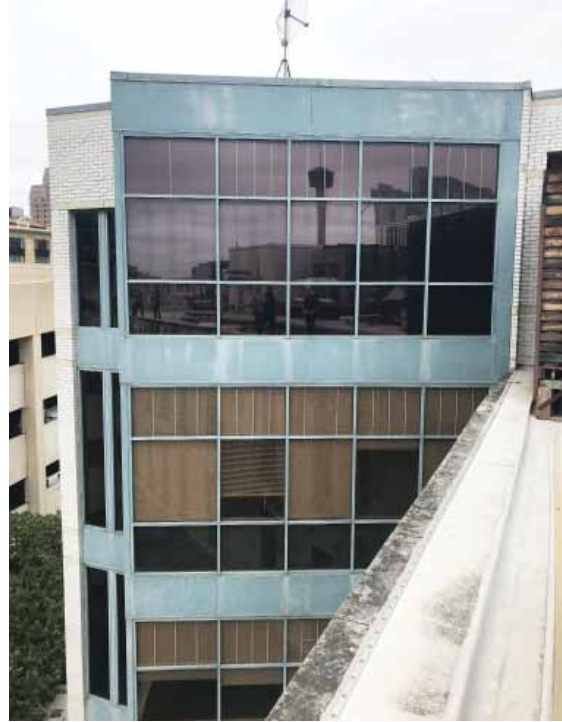
Palace Theater Arcade. South elevation of stair and elevator tower addition constructed during the 1983 renovations. JGWA, 2019.

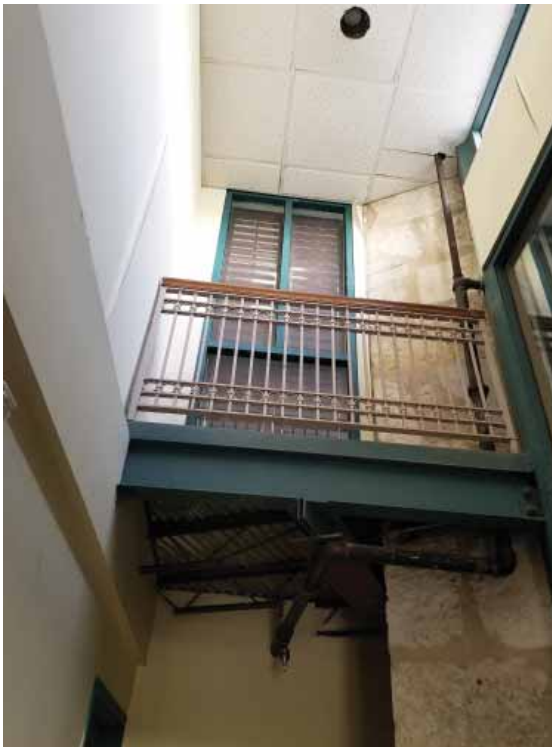
Palace Theater Arcade. Interior of the stair and elevator tower addition, facing east towards the rear (west) exterior wall of no. 323 of the Crockett Block. JGWA, 2019.

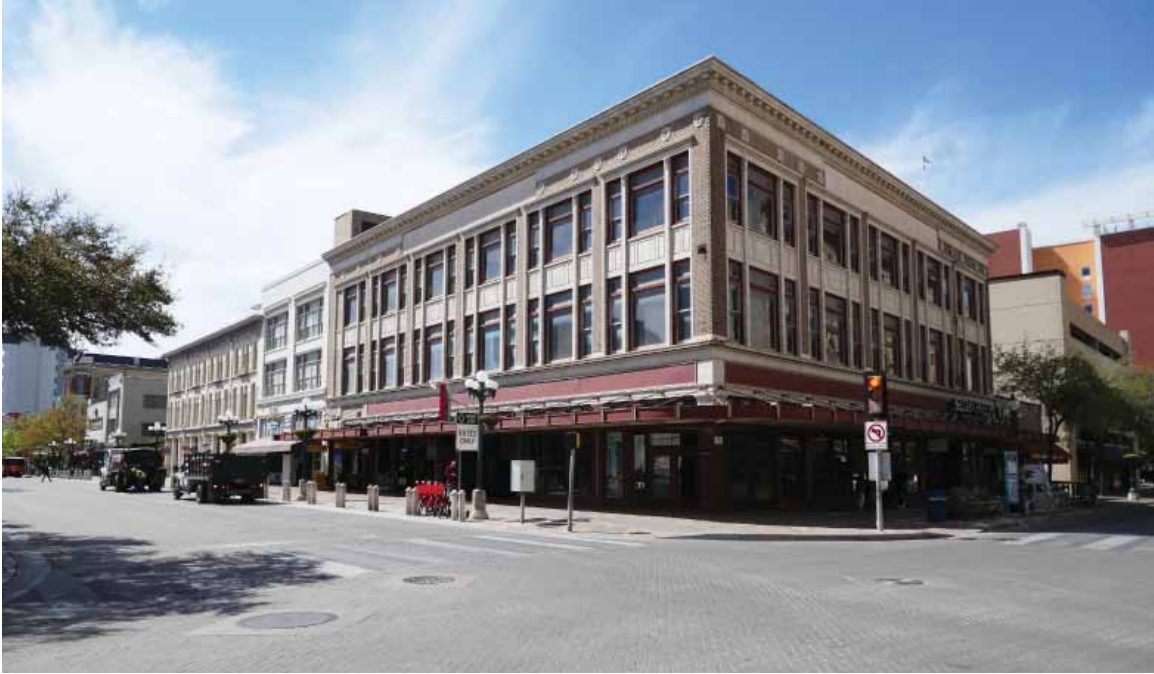
Woolworth Building. View from the northeast. JGWA, 2019.

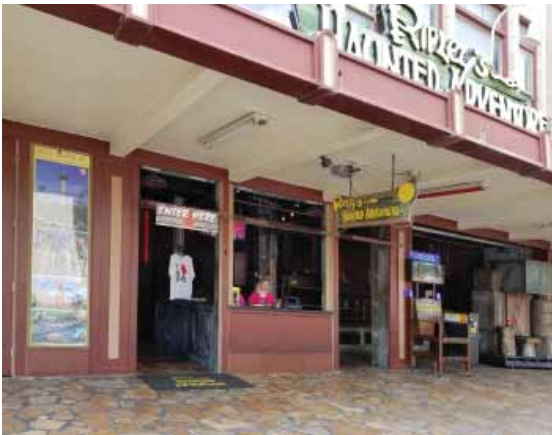
Woolworth Building. East entrances. JGWA, 2019.

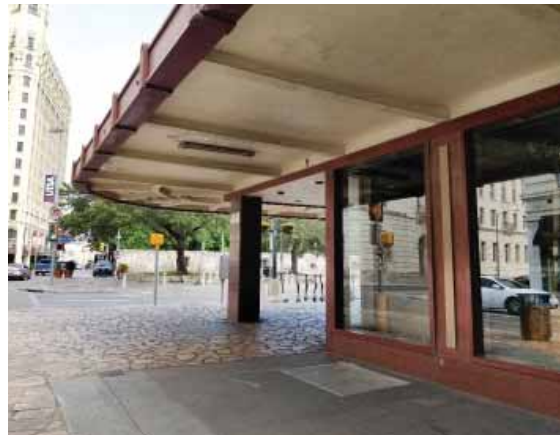
Woolworth Building. Historic canopy at the northeast corner. The concrete patch in the sidewalk is the location of a historic glazed vault light that provided illumination into the basement. The free-standing column was historically clad in terra cotta. JGWA, 2019.

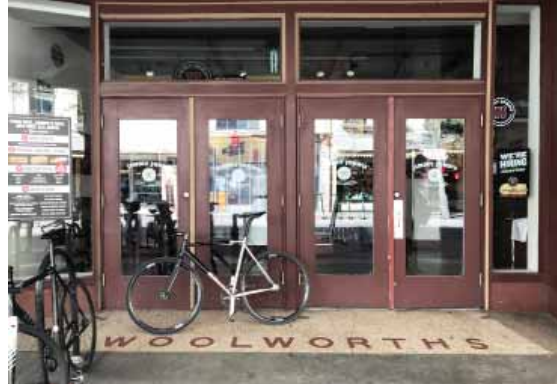
Woolworth Building. Historic north entrance location with terrazzo sidewalk. JGWA, 2019.

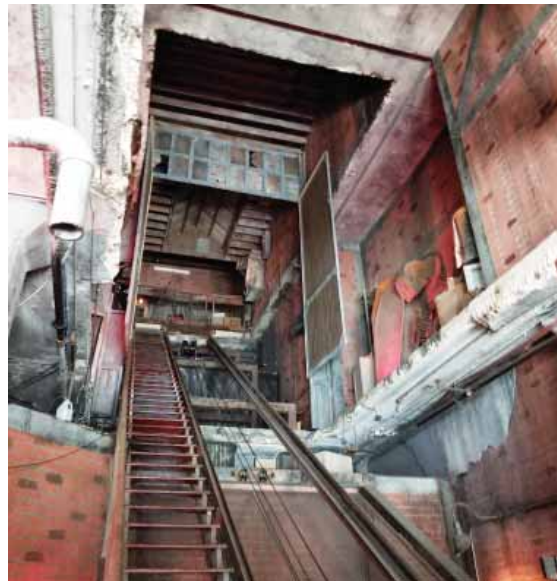
Woolworth Building. The “Ripley’s Haunted Adventure” attraction, looking west up the inclined elevator to the third floor. JGWA, 2019.

**FIRST FLOOR:** Steel columns and framing have been added in locations surrounding non-historic floor openings that extend the full dimension of a structural bay at the south end of the building. These modifications extend up through the third floor to support the inclined elevator used for the Ripley’s Haunted Adventure. A large area of metal deck infill floor framing is located opposite the building’s historic entrance off East Houston Street, and is adjacent to a current floor opening that has been made to accommodate the current amusement ride attractions that emerge from the basement in the northeast corner. A large opening was created to connect the ground floor of the Palace Theater Arcade to the Woolworth Building, but the concrete structural frame of both buildings was not altered.

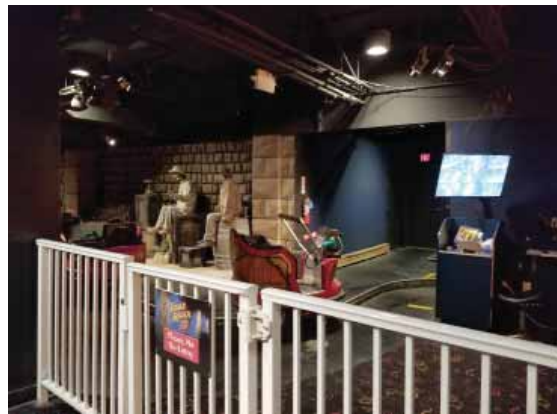
Woolworth Building. The “Tomb Raider” ride in the basement; the ride penetrates the first-floor concrete floor structure at the northeast corner of the building. JGWA, 2019.

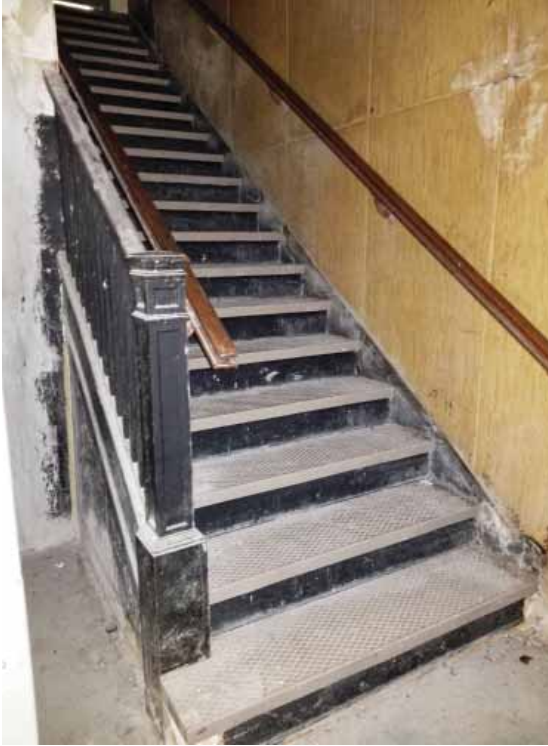
Woolworth Building. Historic stairway from the basement to the first floor at the northwest corner of the building. JGWA, 2019.

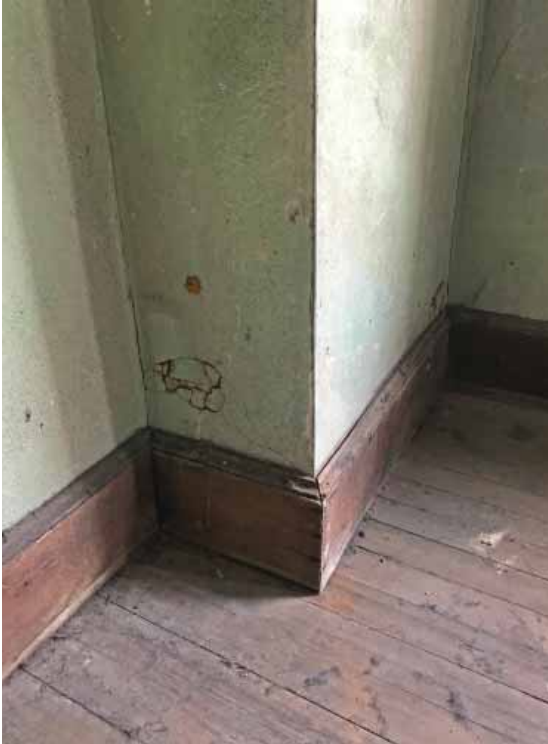
Woolworth Building. Northwest corner of the third-floor, with historic wood flooring and trim. JGWA, 2019.

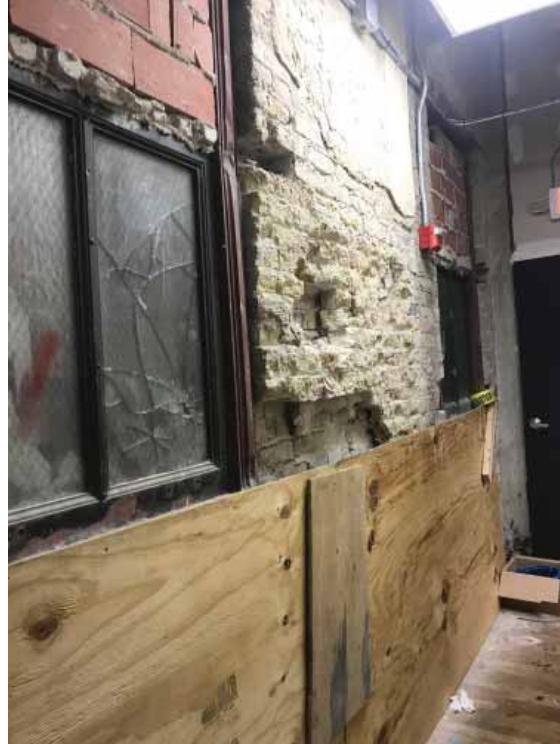
Woolworth Building. West wall of the second floor, where interior finishes have been removed but historic exterior window sash remain. JGWA, 2019.
