# **ALAMO PLAZA EXISTING BUILDINGS**

## **HISTORICAL ASSESSMENT**

**JOHN G. WAITE ASSOCIATES, ARCHITECTS PLLC • SEPTEMBER 2020**

*prepared for the*  
**ALAMO TRUST, INC**

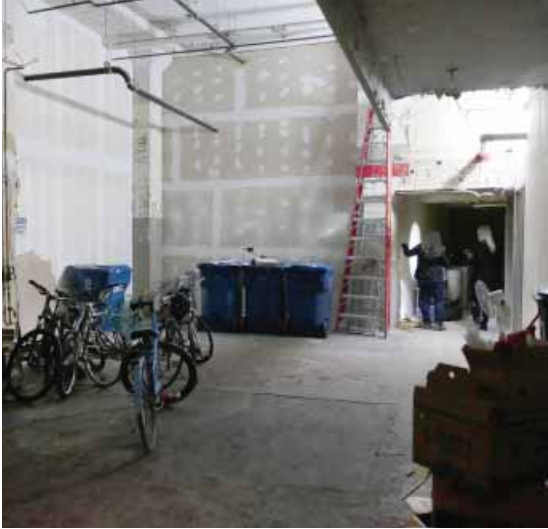
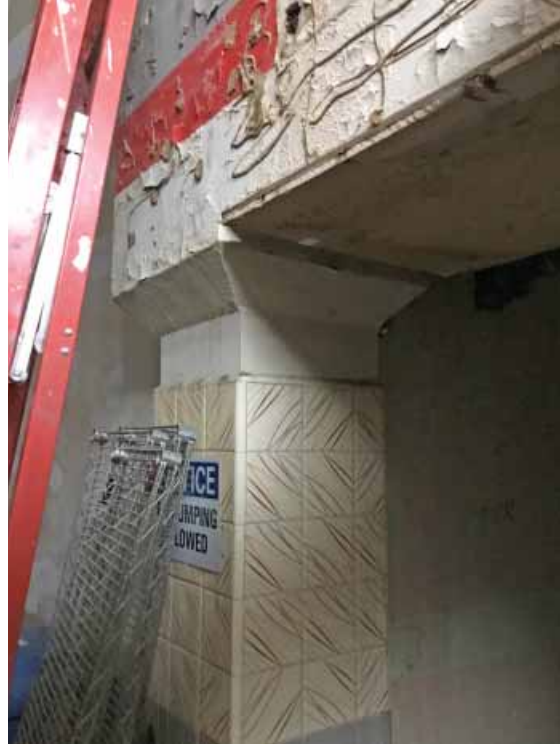
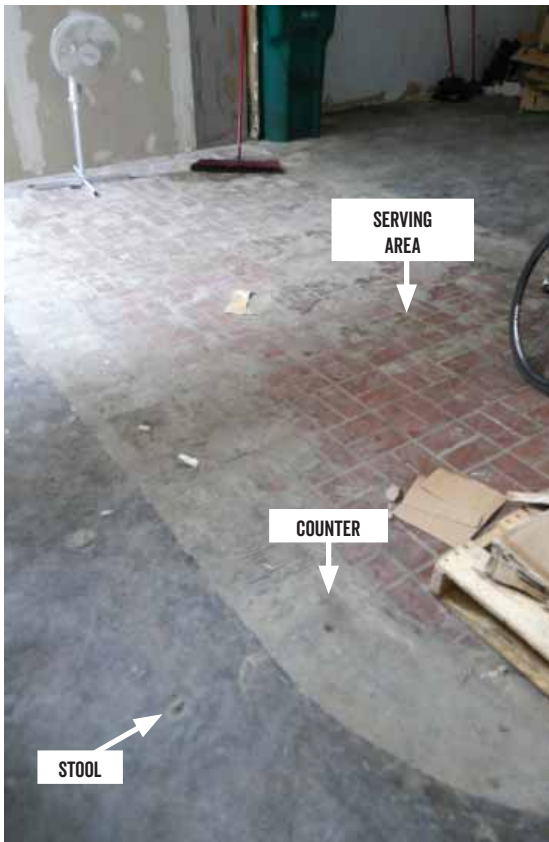
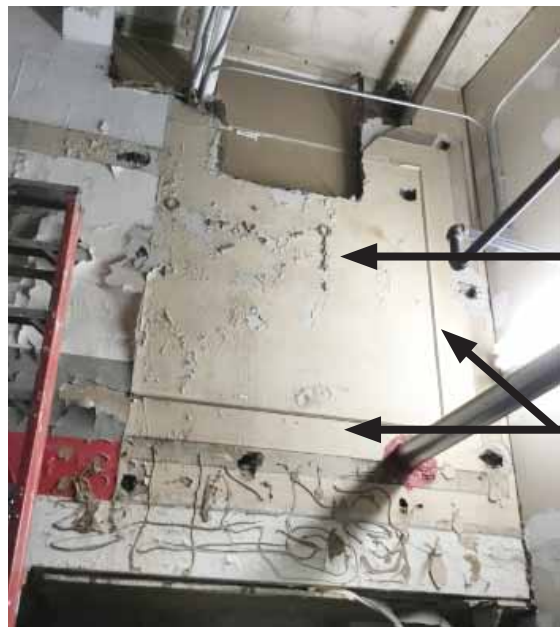
Woolworth Building. Evidence of the historic lunch counter remains in the southwest corner of the first floor. The doorway in the south wall (upper right image) led to the kitchen. The lunch counter area retains remnants of the historic wall treatment, with painted plaster walls surfaces, applied wood trim to create "panels", and composition swag (lower right image). The outline of the counter can be seen on the floor (lower left image). The red tiled area marks the serving area inside of the counter. Round holes along the perimeter of the counter show the location of the stools. JGWA, 2019.

situated in the southwest corner of the first floor. This includes the outline of the complex counter arrangement and seating positions, as well as remnants of ceramic wall tiles and a red and gray stripe paint scheme.

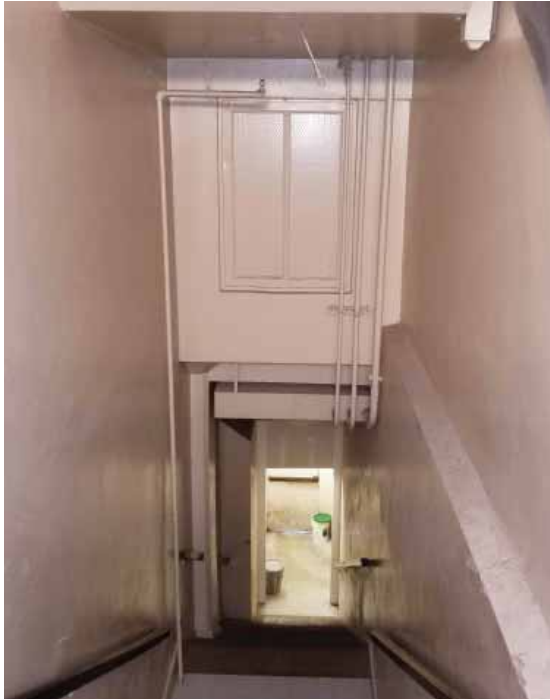
Woolworth Building. Original northwest stair, looking down towards first floor. Note the painted original interior window, which would have provided borrowed daylight from the second-floor spaces into the stairway. JGWA, 2019.

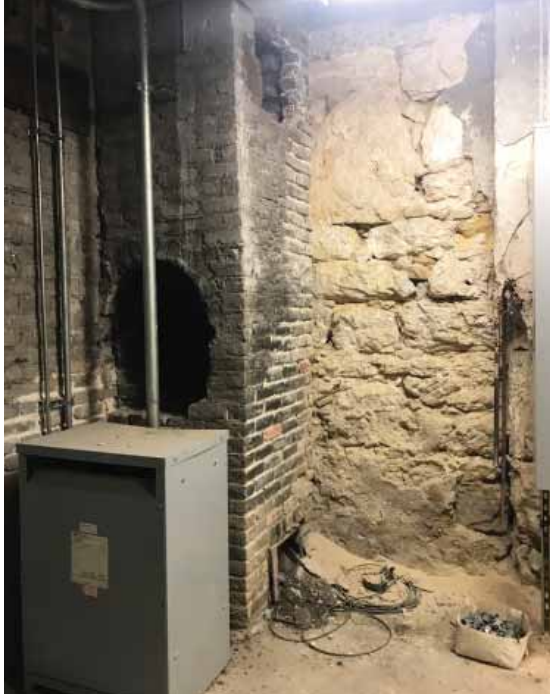
Woolworth Building. Main chimney stack against the west wall. It is possible that the stone foundation wall survives from the Maverick Building, which was demolished for the construction of the Woolworth Building. JGWA, 2019.

Portions of the earlier Maverick Building foundations, including a chimney, remain and have been incorporated into the electrical room.

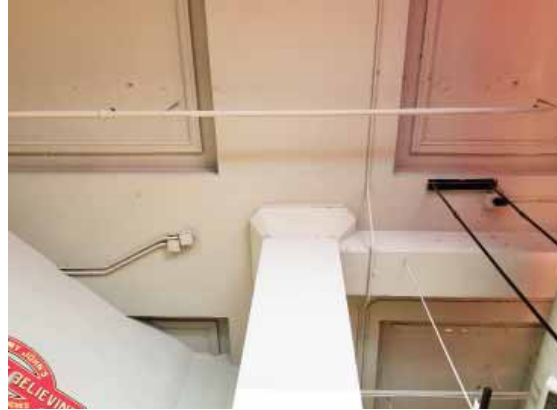
Woolworth Building. First-floor concrete pier with applied profiled wood trim, supporting the coffered plaster ceiling. JGWA, 2019.

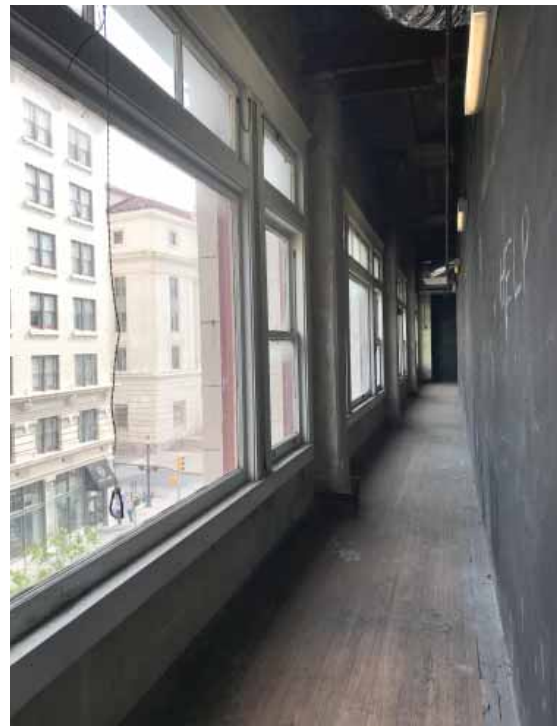
Woolworth Building. Third-floor north hallway, looking east. Historic finishes, including painted surfaces, remain in this location. JGWA, 2019.

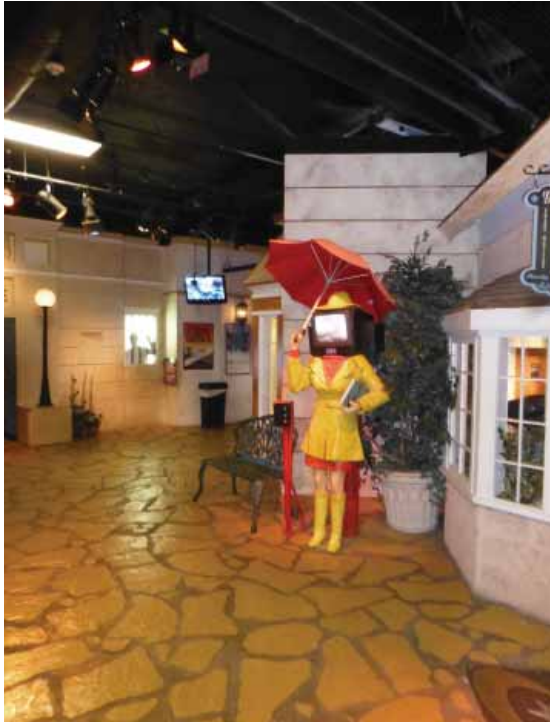
**Woolworth Building.** The second floor of the building, where the “Guinness Book of World Records” attraction is also located. JGWA, 2019.

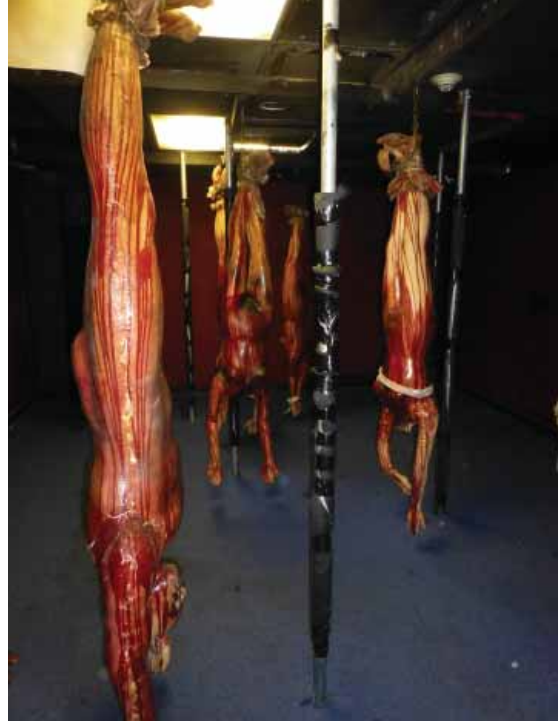
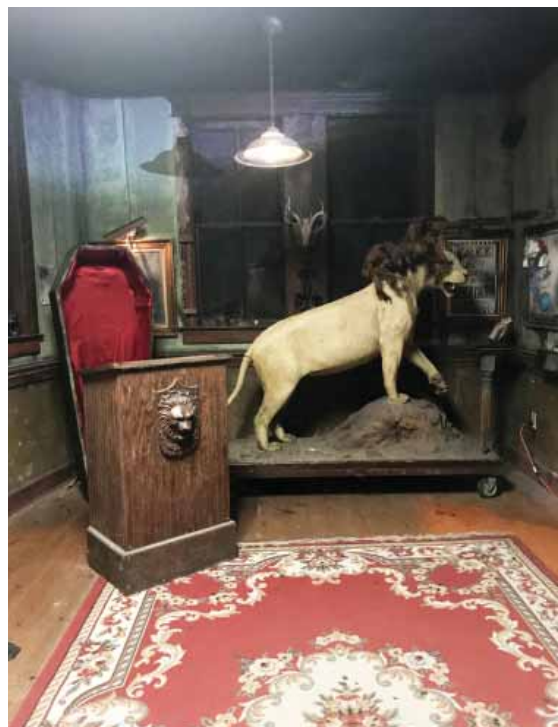
**Woolworth Building.** “Ripley’s Haunted Adventure” attraction on the third floor. In the lower photograph, the room retains historic windows and finishes that have been incorporated into the backdrop for the attraction. JGWA, 2019.

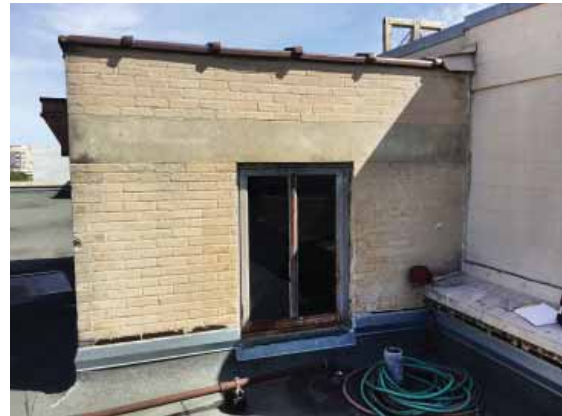
Woolworth Building. Historic penthouse structure at southwest corner of roof. JGWA, 2019.

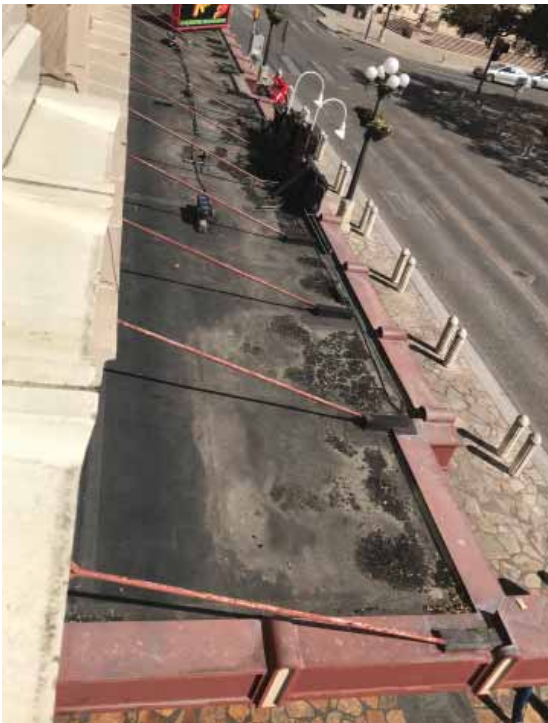
Woolworth Building. Looking north down at the structural support rods and roof surface of the historic canopy over the sidewalk. JGWA, 2019.

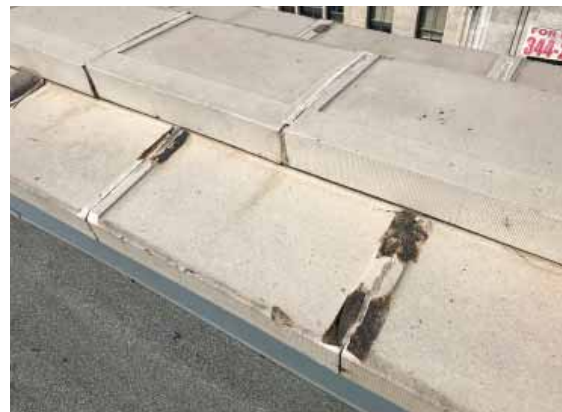
Woolworth Building. Terra cotta parapet at the north facade, with failed sealant at many joints between units. JGWA, 2019.

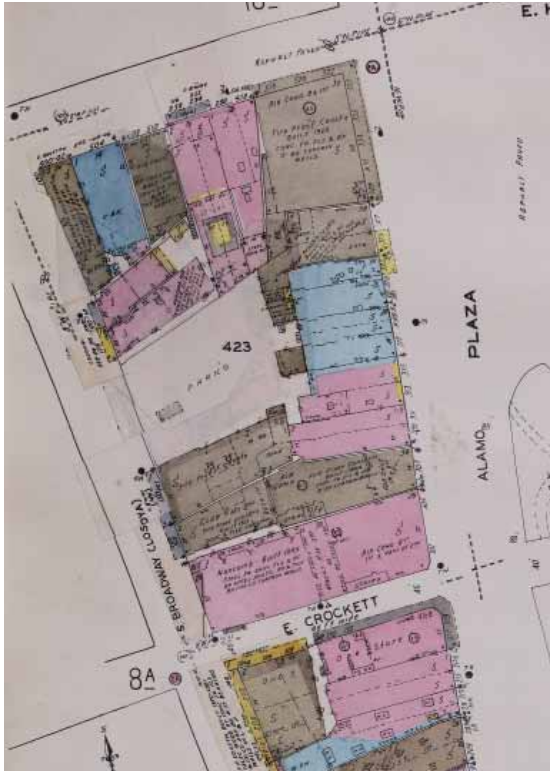
Fire-insurance map from 1971 showing the buildings on the block bounded by Houston Street, Alamo Plaza, Crockett Street, and South Broadway at that time.

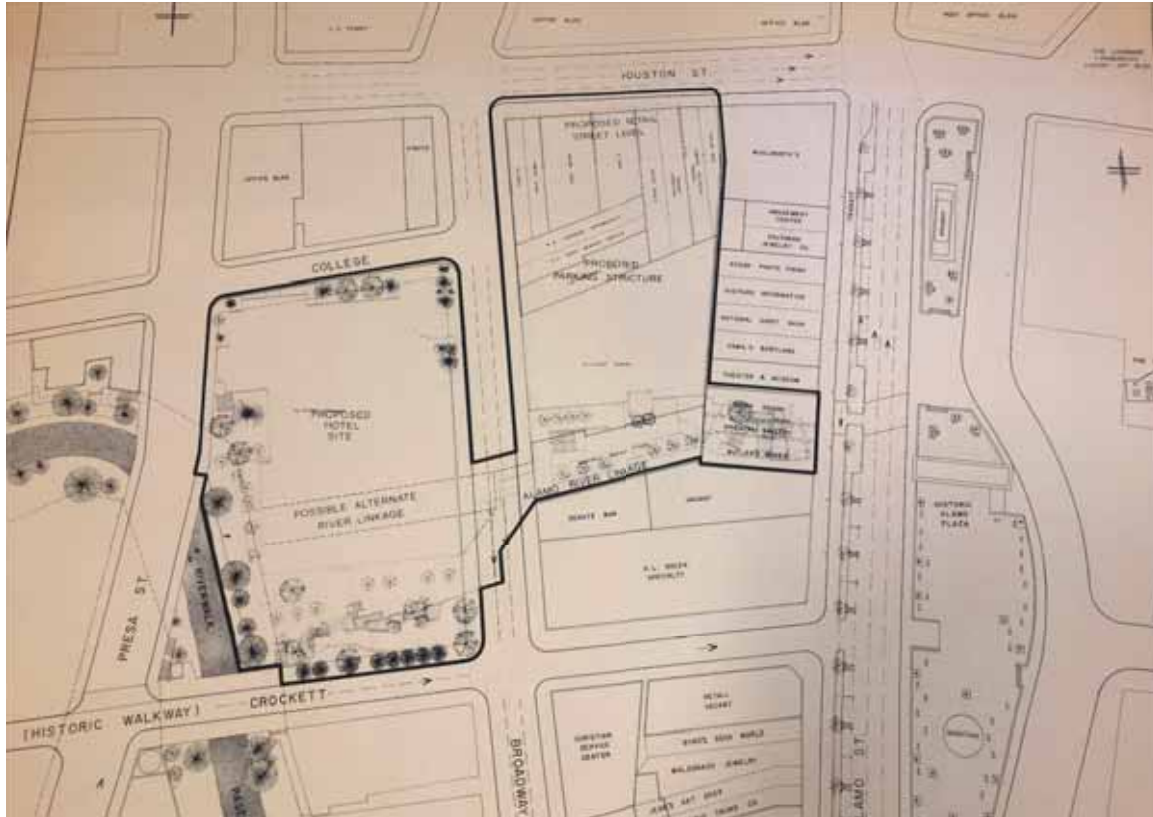
Map showing boundaries of the proposed UDAG project, November 1977.  
City of San Antonio: Department of Planning. Alamo Plaza—Paseo del Rio Linkage Project, Nov. 1977.

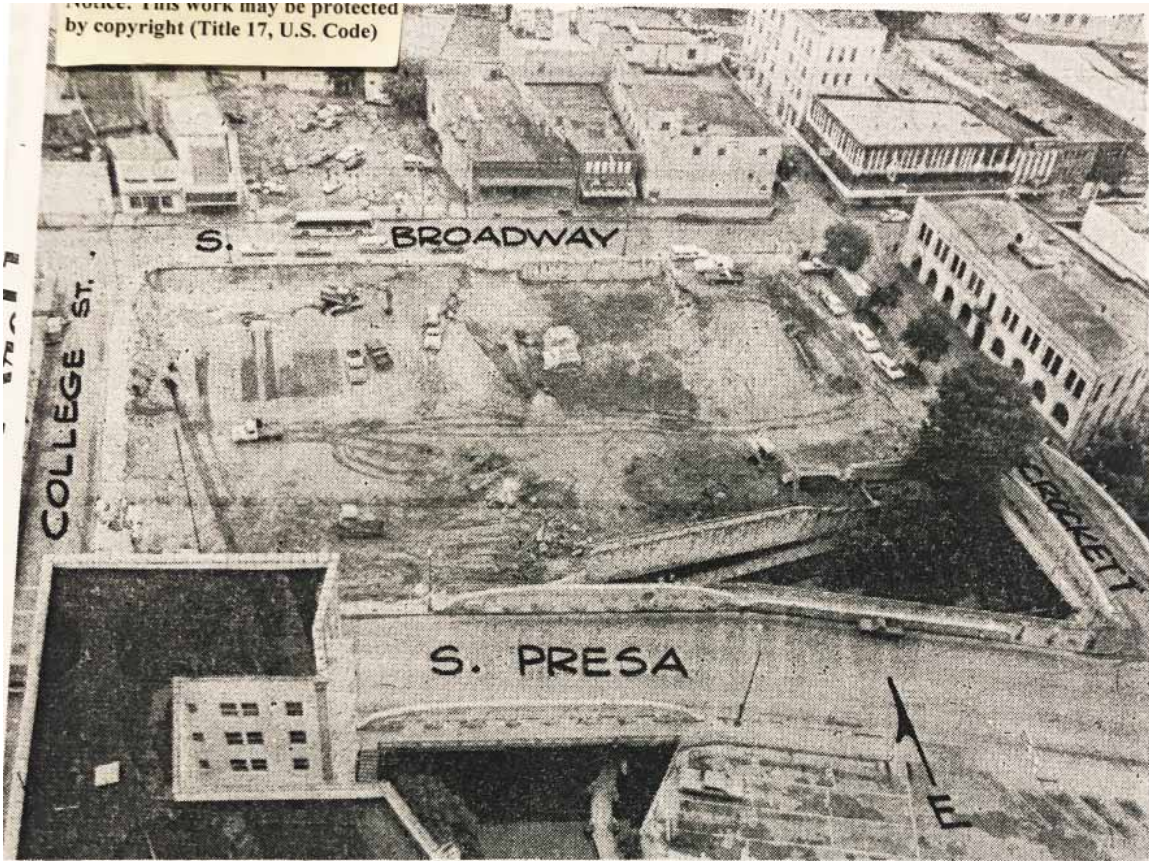
Aerial view looking east showing progress of construction of hotel and some of the buildings, east of Broadway, still on the site of the garage, August 1979.

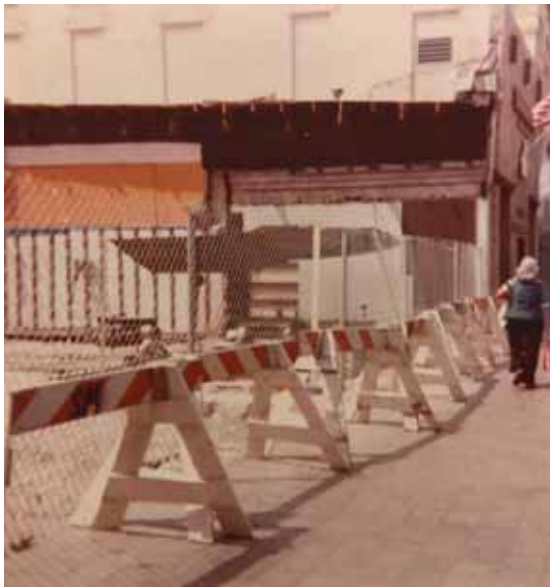
View looking north along Alamo Plaza as the Radio Shack building was being demolished, ca. 1980.  
Demolition of Radio Shack building in progress, San Antonio municipal files.

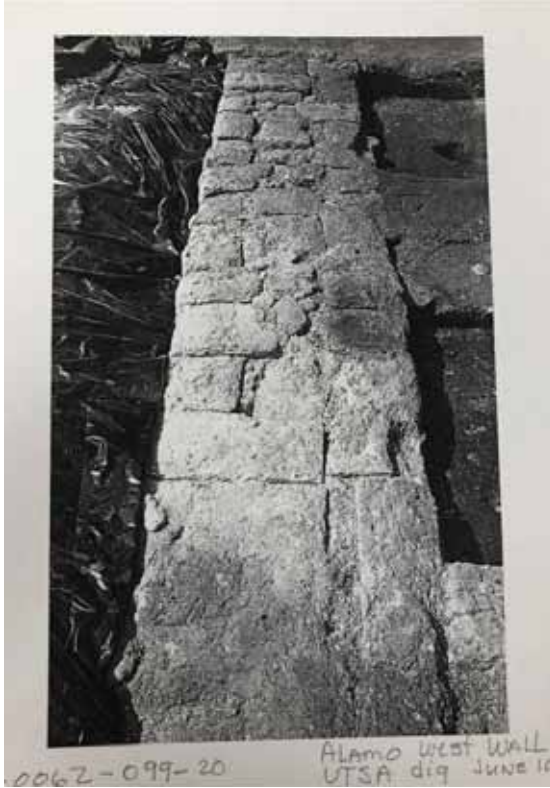
Adobe wall uncovered by archeologists during excavations in 1979-1980; photograph dated June 10, 1980. 1980, archeology investigations after demolition, Institute of Texan Cultures, UTSA Special Collections E-0062-099-21.

The archeological excavations continued until June 1980. Another description of the work stated that the “foundation of the western wall of the Alamo as well as adobe buildings and an acequia channel were uncovered and recorded. In all, almost half of the site was excavated by archaeologists before bull dozers were allowed to raze the building. The exposed features were later reconstructed above ground in the park.”<sup>64</sup>

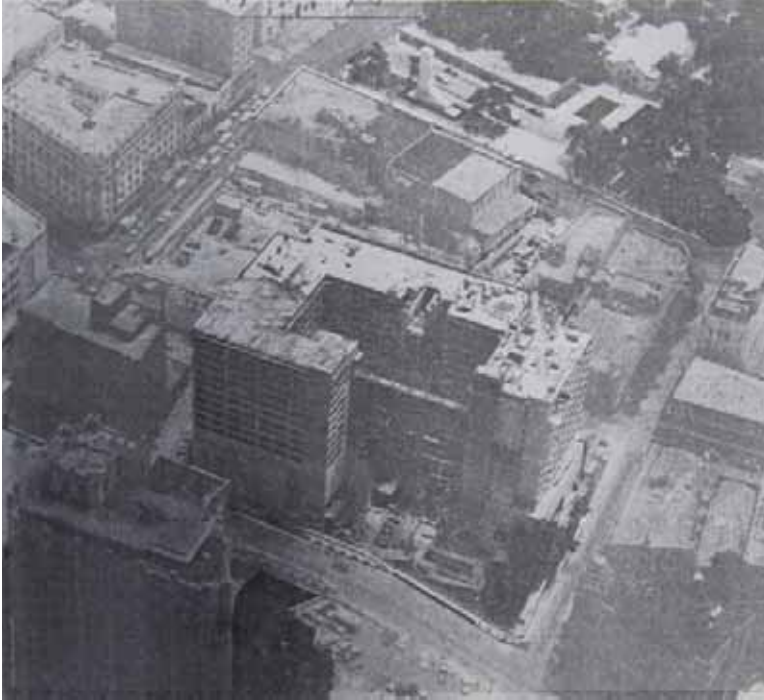
Aerial view of the project in July 1981, when the hotel was nearly complete and the garage and linkage project were underway.  
*San Antonio Express*, July 9, 1981.

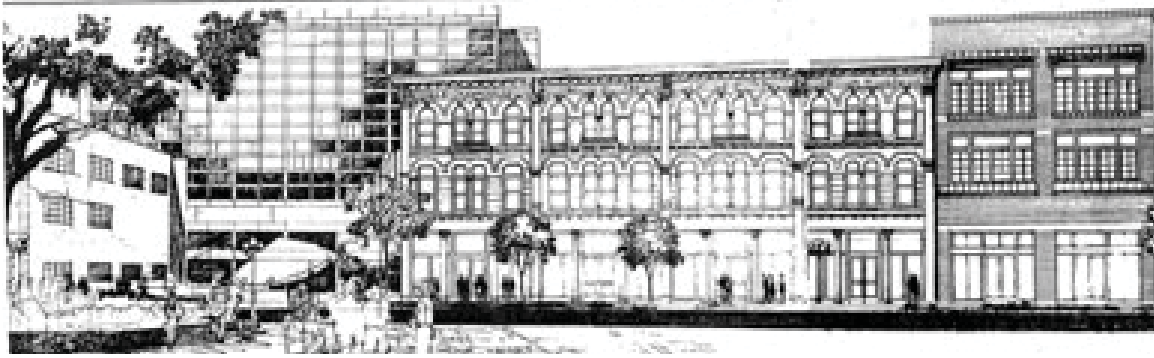
Rendering of the west side of Alamo Plaza, showing 309–315 Alamo Plaza as having been demolished, 1982.  
Anne Pearson, “Alamo Plaza Buildings to be Restored,” *San Antonio Express*, Nov. 12, 1982.
